R 715

**AMPHIBIOUS ASSAULT LANDING CRAFT PROGRAM—
LARGE PALLET DEVELOPMENT**

March 1971

NAVAL CIVIL ENGINEERING LABORATORY

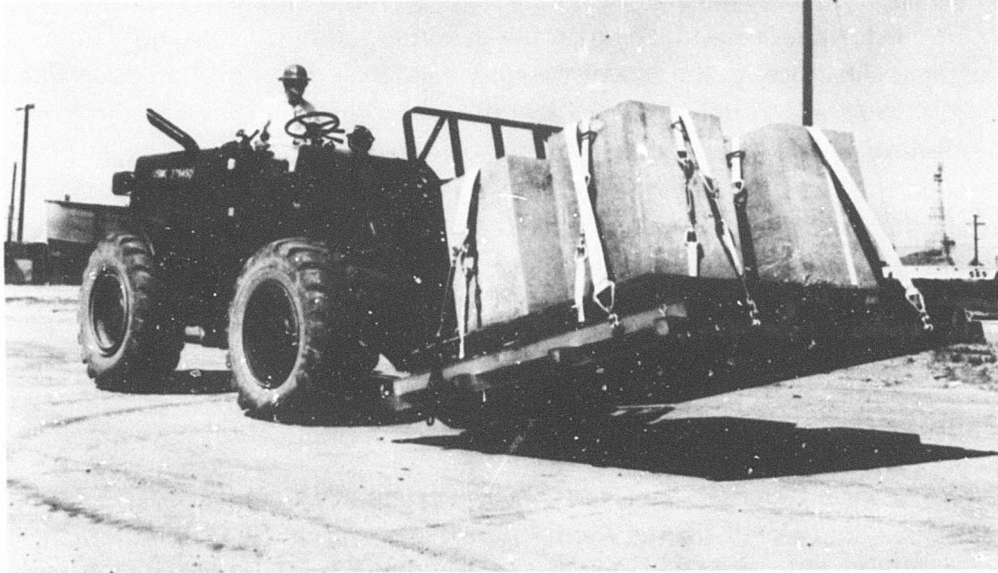
Figure 1. Wooden large pallet during initial forklift operations.

The first, a wooden pallet, was designed to be low in cost and disposable. It was built with construction-grade 4 x 4's and 1/2-inch 32/16 unsanded plywood in accordance with the deck-loading criteria presented in the American Plywood Association booklet on pallet design.* Figure 1 shows the wooden pallet loaded and ready for testing. The approximate weight of the wooden pallet is 600 pounds, and the prototype cost was \$335. A drawing of details is presented in Figure A-1 of the Appendix.

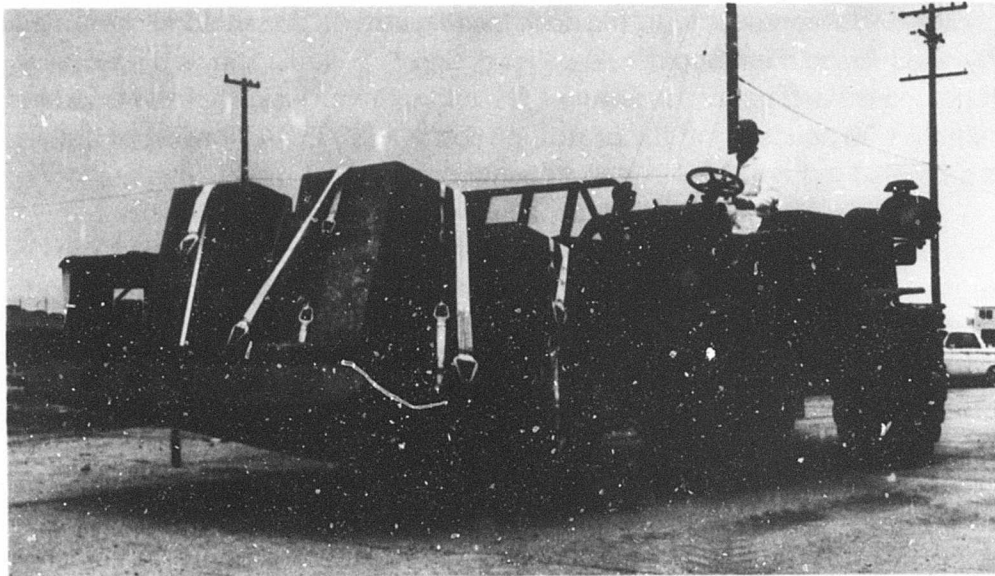
Figure 2. Folded-plate large pallet (steel construction) during initial forklift operations.

The second, a folded-plate pallet, was developed for low-cost production, compact storage, and ease of handling. Four such pallets can be stacked in a space 9 inches high; the stack can be easily disassembled and the pallets loaded with a minimum amount of handling, since the stack is disassembled by sliding the pallets off the top and no time is wasted discriminating the top of the pallets from the bottom. This pallet weighs approximately 1,200 pounds, is built of 1/8-inch steel, and its prototype cost was approximately \$1,000. It was originally intended as an aluminum pallet weighing about 400 pounds. However, the high cost of hand fabrication involved in prototype construction of such an aluminum pallet was prohibitive, thereby justifying the use of a steel alternative for test purposes. Mass production of

this folded-plate pallet in aluminum is anticipated to have low cost, since construction on a production basis is a two-step operation—punching out the tine opening and breaking (folding) the plate. A detail drawing of the folded-plate pallet is presented in Figure A-2 of the Appendix. Figure 2 illustrates the pallet loaded and ready for testing.

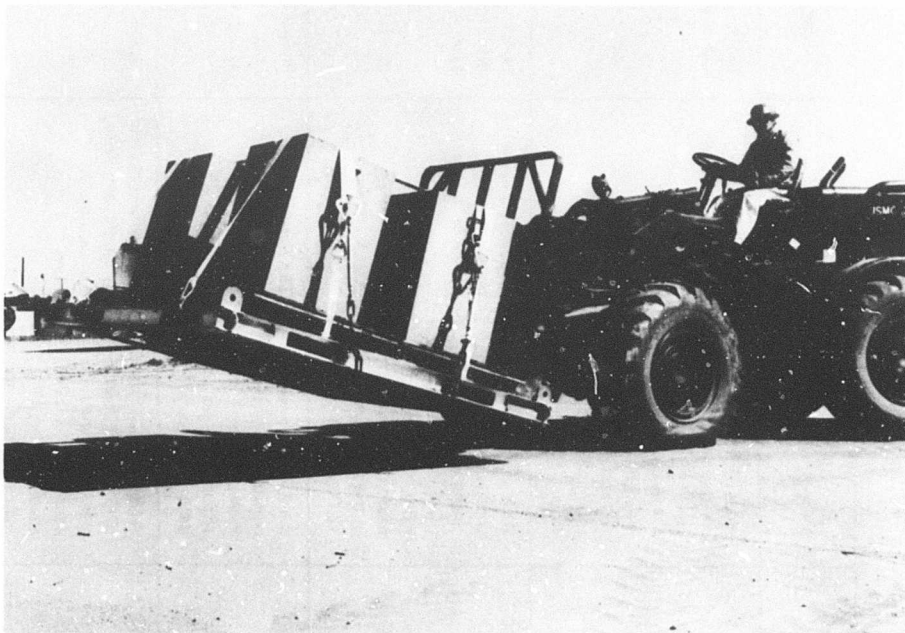
Figure 3. Aluminum large pallet during initial forklift operations. (Note wheel loading.)

The third, an aluminum pallet, is of the conventional design to provide some comparison with known performance capabilities. The pallet was first designed for steel construction, but the weight requirement necessitated an alternative aluminum design. This pallet served a secondary function as a spreader for lifting the more pliable wooden and folded-plate pallets. Prototype cost for this 600-pound pallet was \$2,000. Figure 3 shows the loaded pallet positioned for testing. Details of the design are presented in Figure A-3 of the Appendix.

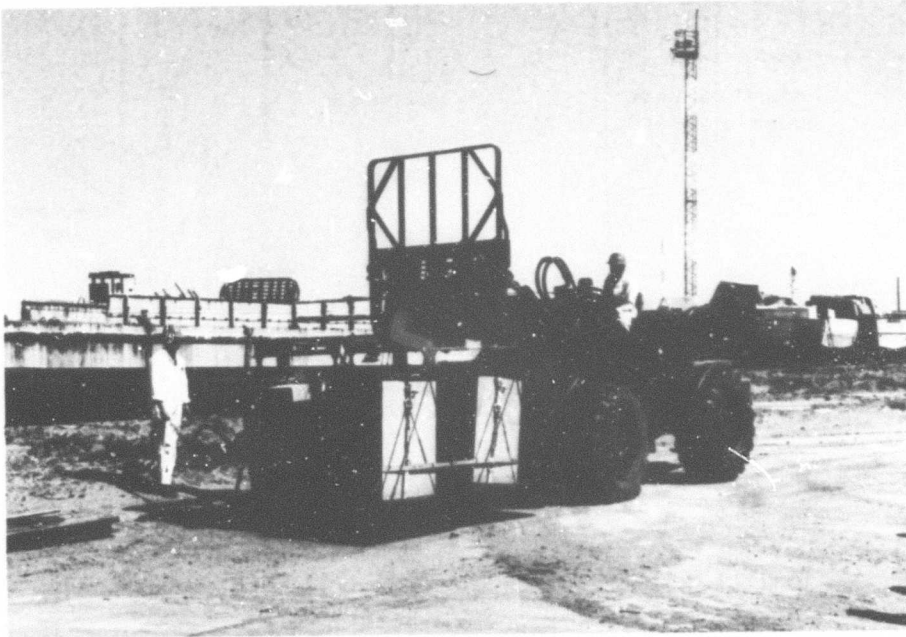
Figure 4. Typical forklift loading of strongback large pallet during initial rigging for test program. (Note standard pallet override.)

A fourth pallet was delivered to NCEL for testing from Hunters Point Naval Shipyard. This strongback pallet has been shown* to be the most compatible large pallet from the standpoint of shipboard handling. Figure 4 shows the pallet loaded and positioned for testing. Figure A-4 of the Appendix gives details of the design. Prototype cost for this 325-pound pallet was \$753. A summary of specific design criteria and general description of each pallet are presented in Table 1.

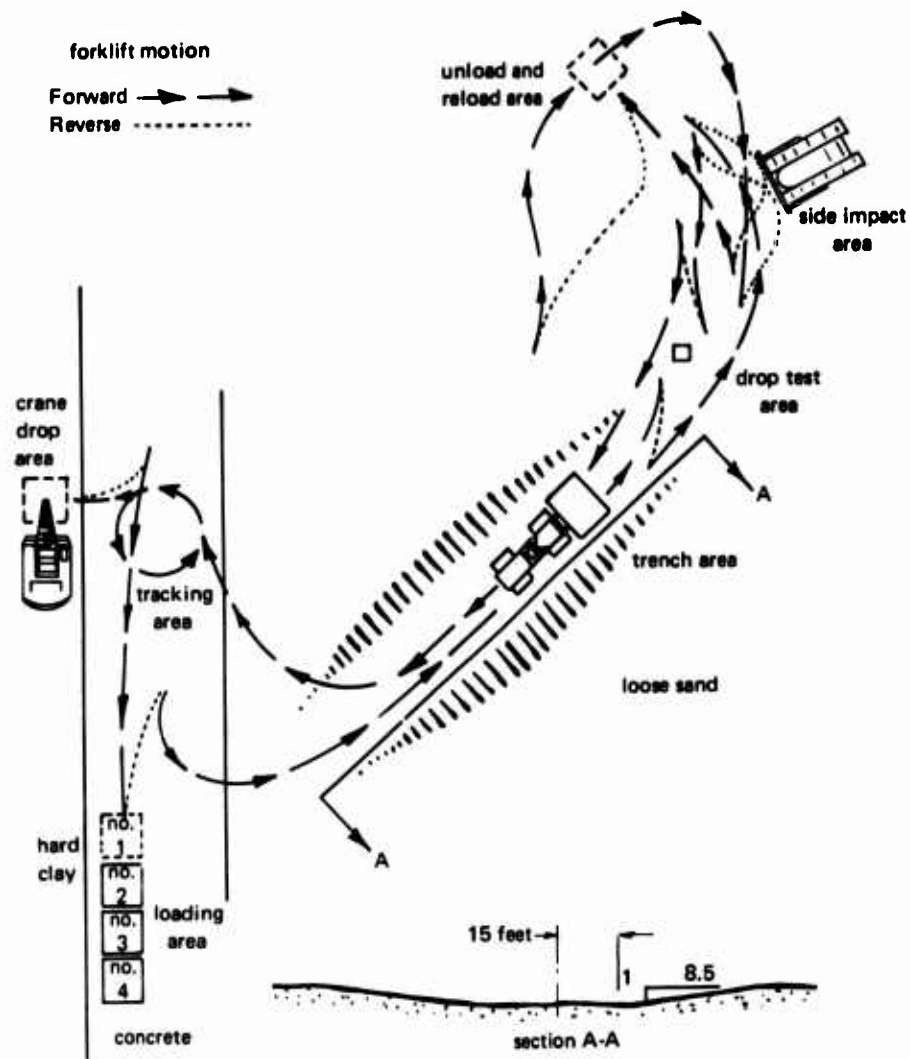
Figure 5. Forklift maneuvering procedure and site description. (Not to scale.)

The general test program, which was applied to all pallets except the strongback, is illustrated in Figure 5 and described as follows:

The loading and tractability portions of the tests were performed on concrete pavement. Both crane operations were conducted on densely compacted clay and the remainder of the test procedure in loose sand. A general schematic of the area and test procedure are presented in Figure 5.

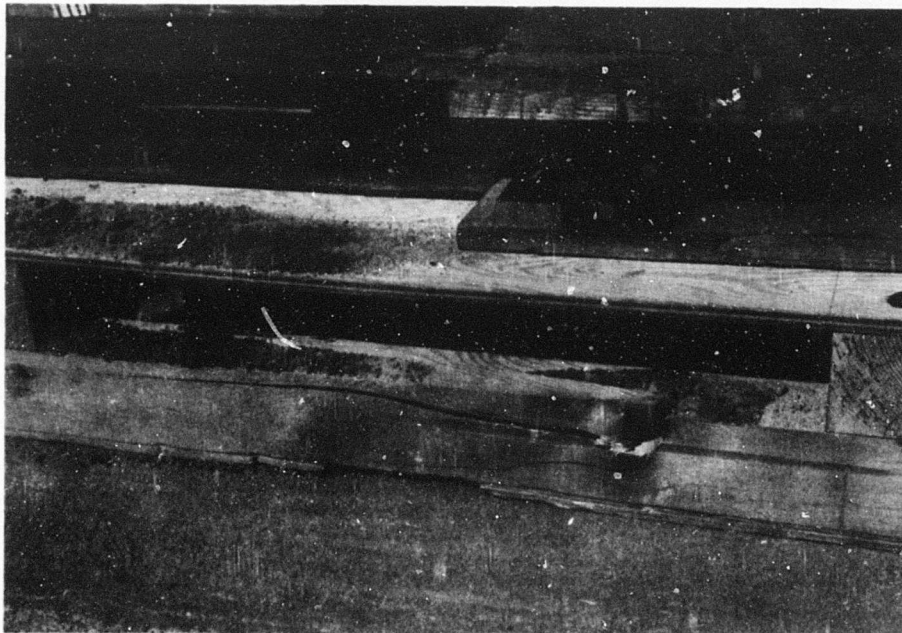
Figure 6. Damage to wooden large pallet prior to the crane drop tests (an exaggeration of initial checks).

Figure 6 illustrates damage to an exterior beam prior to the crane drop tests. This damage is an exaggeration of an initial flaw in the timber that was further developed during the drop tests performed by the forklift.

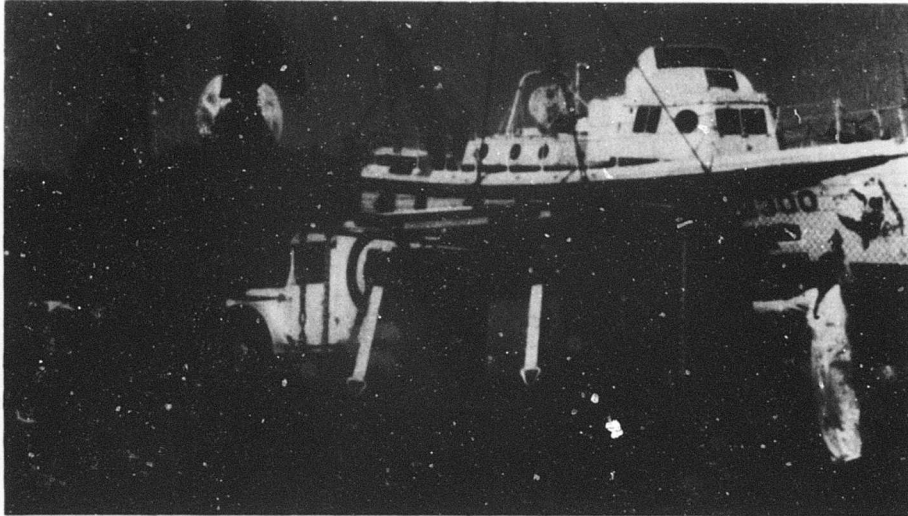
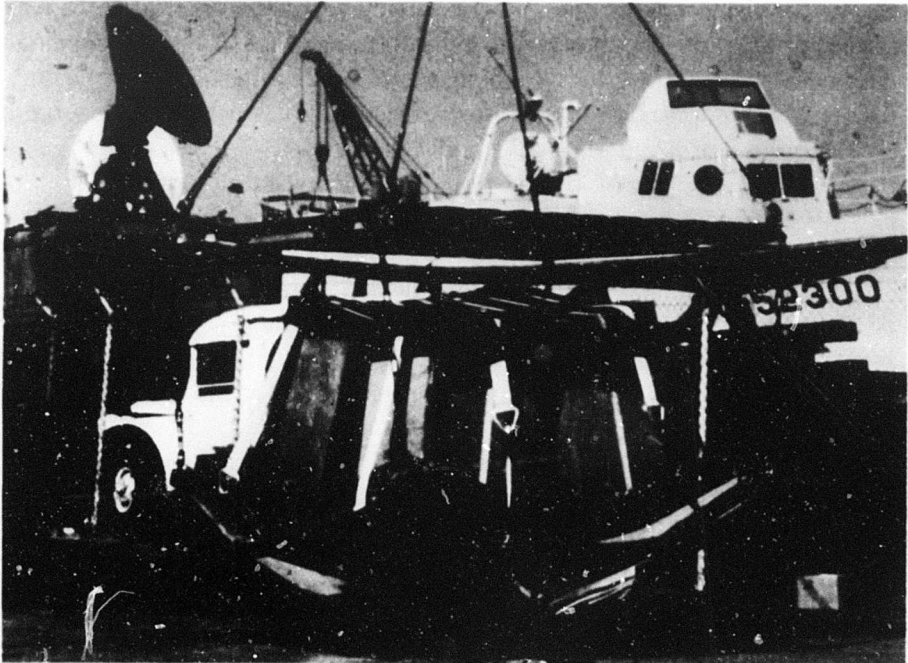
(a) First drop.

(b) Second drop.

Figure 7. Wooden large pallet during crane drop tests.

The four-point lift test performed on the pallet resulted in excessive deformation in the 4 x 4 beams, although by this time checks were fully visible in the 4 x 4 framework. Lifting the pallet was possible; however, on the first drop the pallet nearly failed in that deflections were excessive. On the second drop failure occurred (see Figure 7). In all cases failure occurred at bolt joints and knots of the 4 x 4's (Figure 8). Several eye bolts failed during the destruction although the lifting eye assembly for the four-point lift performed satisfactorily with only slight indications of shear initiation in the timbers (Figure 9).

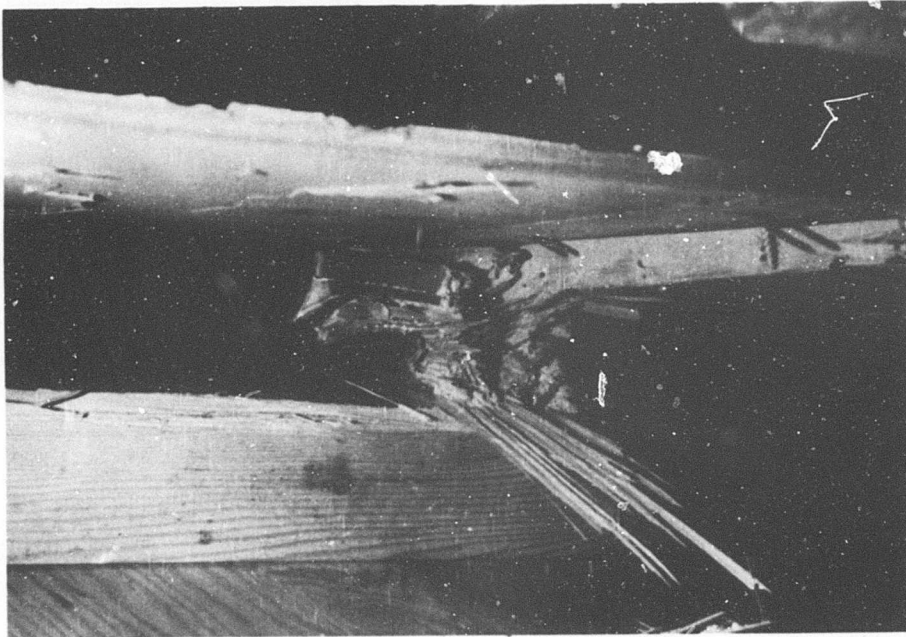
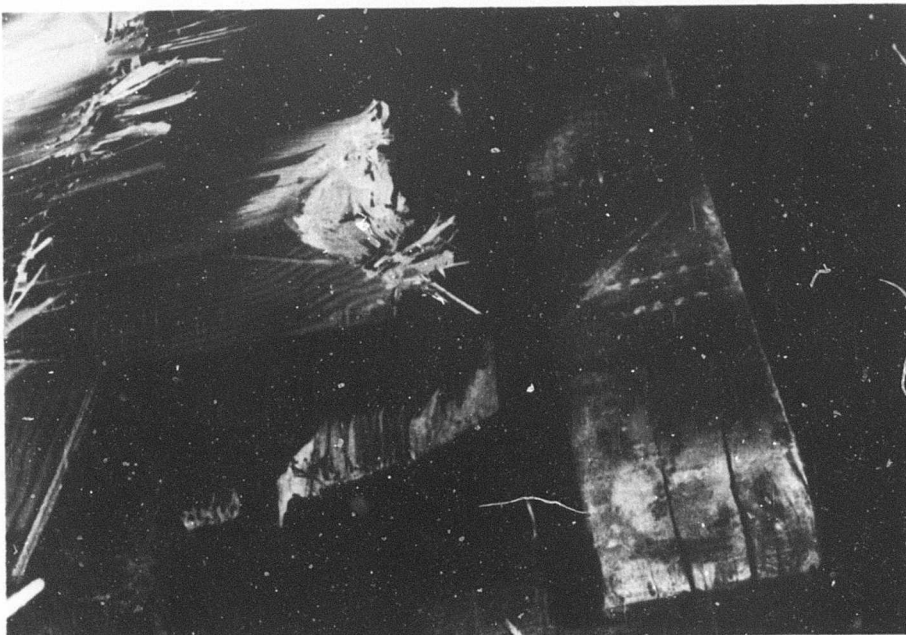
(a) At bolt connections.

(b) At knots.

Figure 8. Wooden large pallet failures from crane drop tests.

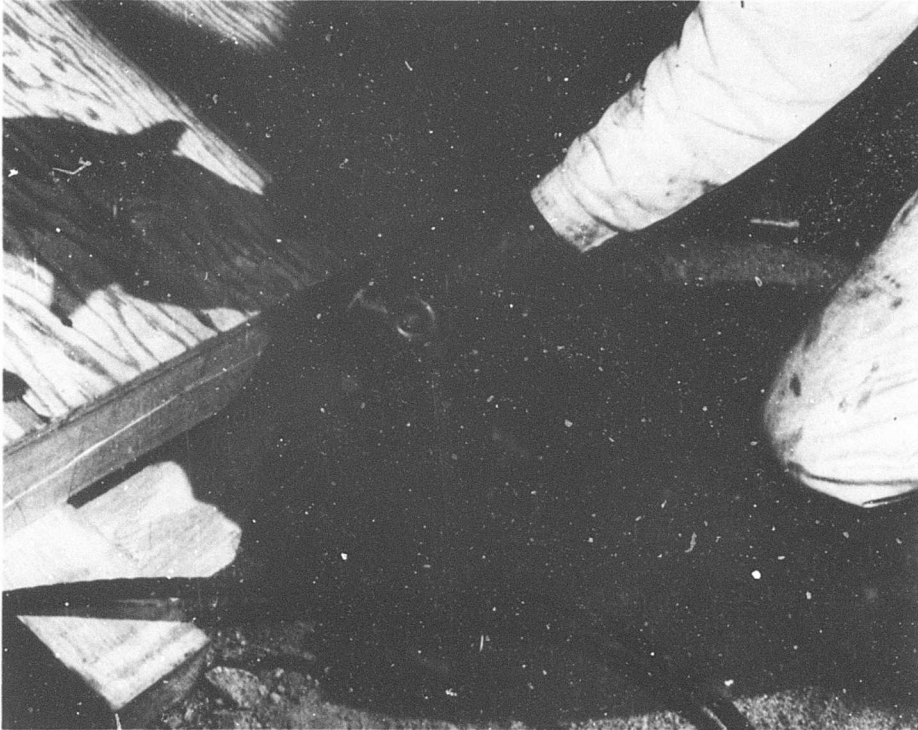
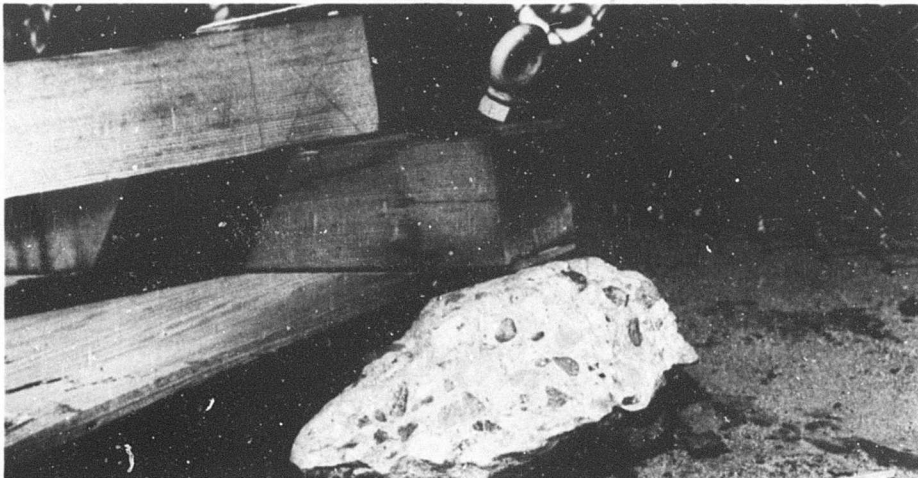
(a) Typical tie-down.

(b) Typical lifting eye.

Figure 9. Damage to tie-down and lifting points of wooden large pallet after crane drop tests.

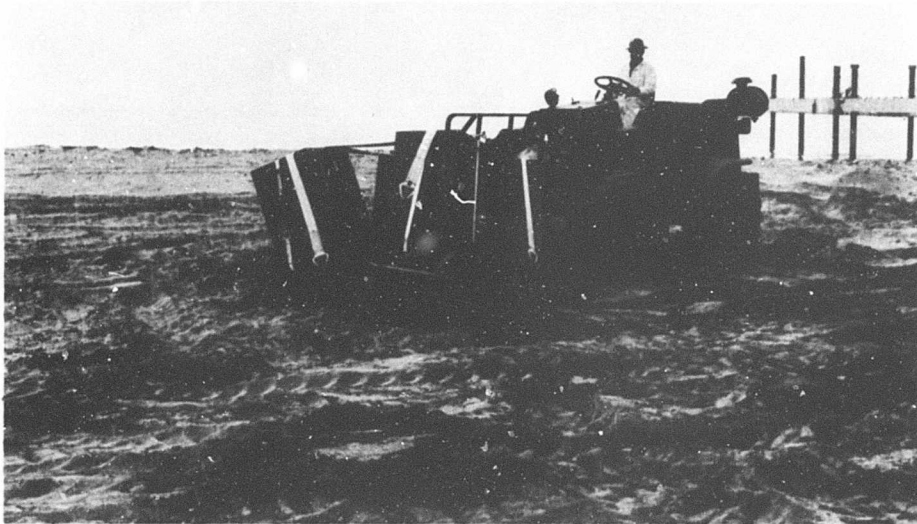
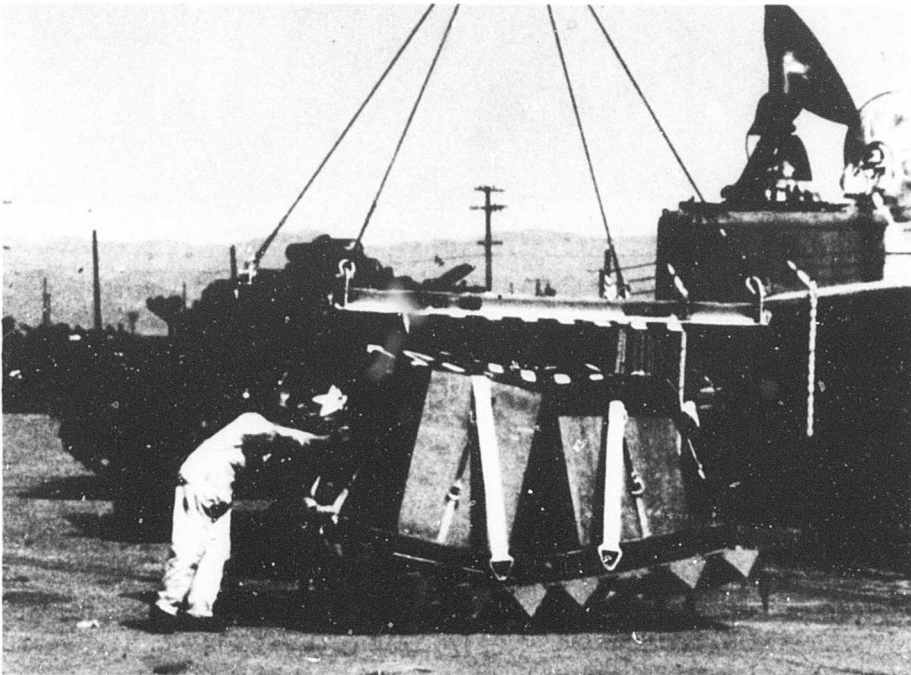
(a) Drop test.

(b) Four-point crane lift.

Figure 10. Flexibility of folded-plate pallet.

During the drop test its extreme flexibility proved an asset to its life expectancy, but the standard wooden pallets were destroyed (Figure 10a). Failure of the wooden standard pallets was primarily a bearing failure due to stress concentrations developed on the wooden pallet at the breaks (folds) of the folded plate. The extreme flexibility, however, required rigging the pallet several times in the performance of a test program, especially after the standard pallets failed, since the strapping would loosen excessively. Little damage occurred to the large pallet itself during any portion of the forklift operation, although the side gusset plates had buckled.

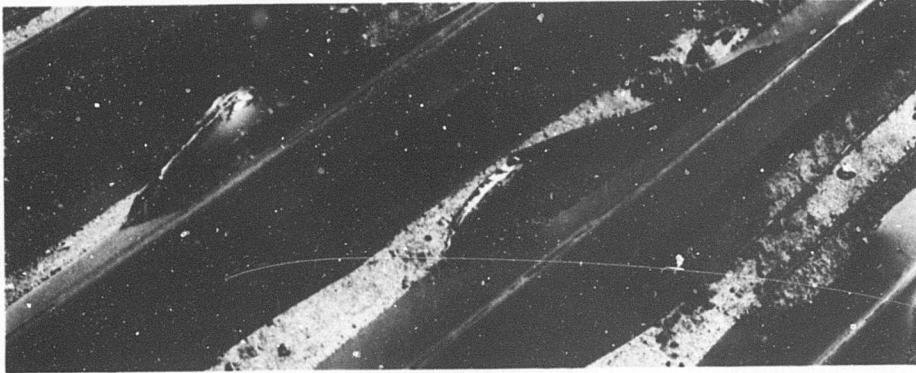
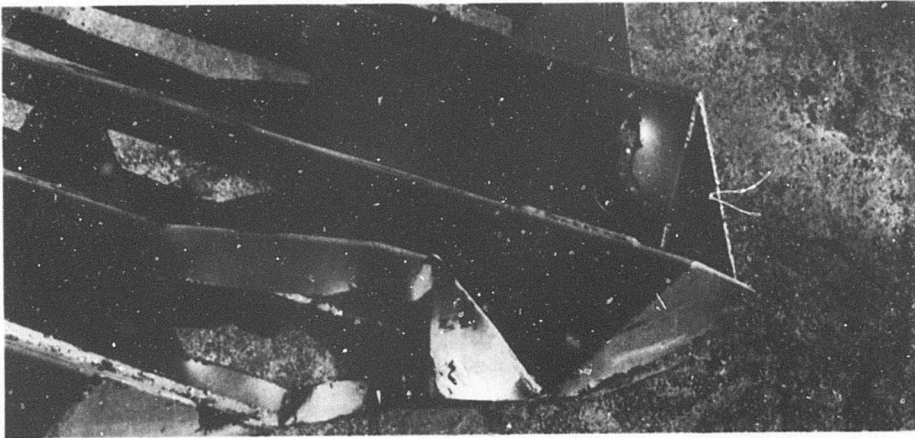
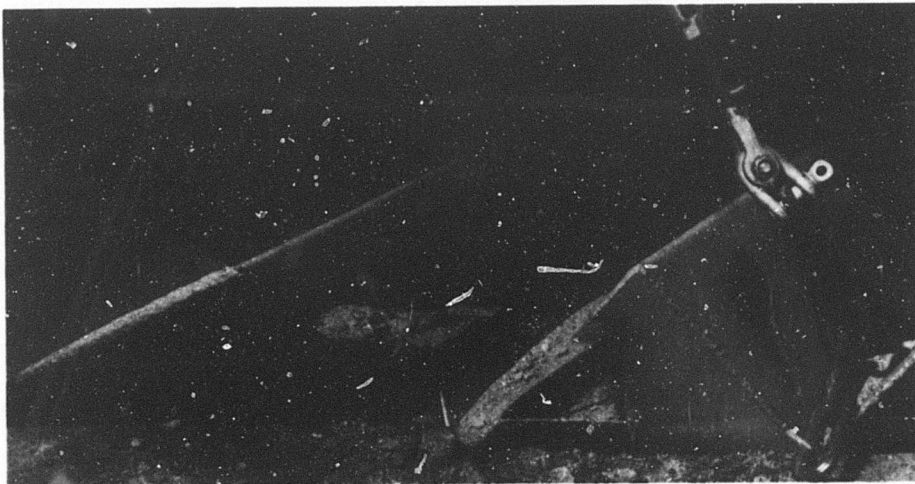
(a) Tine opening after first forklift operation.

(b) Grab-eye damage after crane drop tests.

(c) Gusset tear after crane drop tests.

Figure 11. Typical damage to folded-plate pallet.

Crane operation with the folded-plate pallet was difficult because of its flexibility. Although it functioned satisfactorily through the series of free falls, damage to the standard pallets was again extensive. The grab-eye lifting points worked exceedingly well in this portion of the test; none failed (Figure 11).

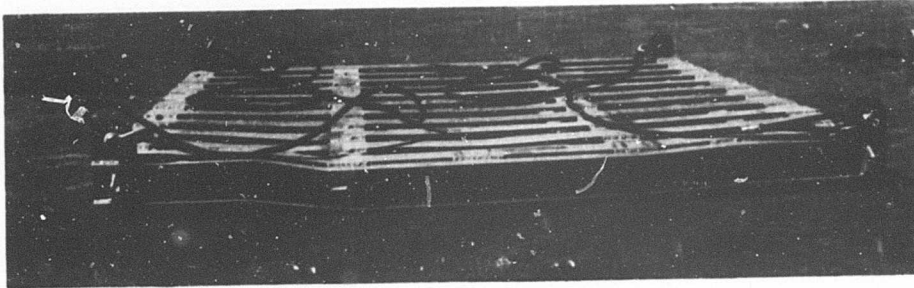
Figure 12. Damage to aluminum pallet after nonscheduled drop test onto 12 x 12-inch wooden block on concrete pavement.

Aluminum Pallet. The aluminum pallet was the third tested and it performed exceptionally well throughout all portions of the scheduled test. No failure was initiated in any portion of the scheduled program. The pallet failed structurally, however, when a nonscheduled drop test on concrete pavement was performed at the suggestion of the sponsor. Although permanent deformation was evident (Figure 12), damage was neither sufficient to prevent tine insertion nor to deter any functional requirement of the large pallet.

Drop test performed on pavement (nonscheduled)	not applicable	not applicable	good	not applicable	Resulted in permanent deformation, yet pallet retained its functional abilities.

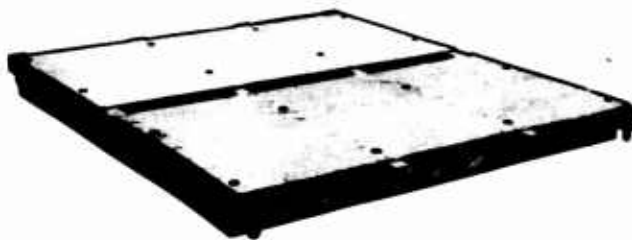
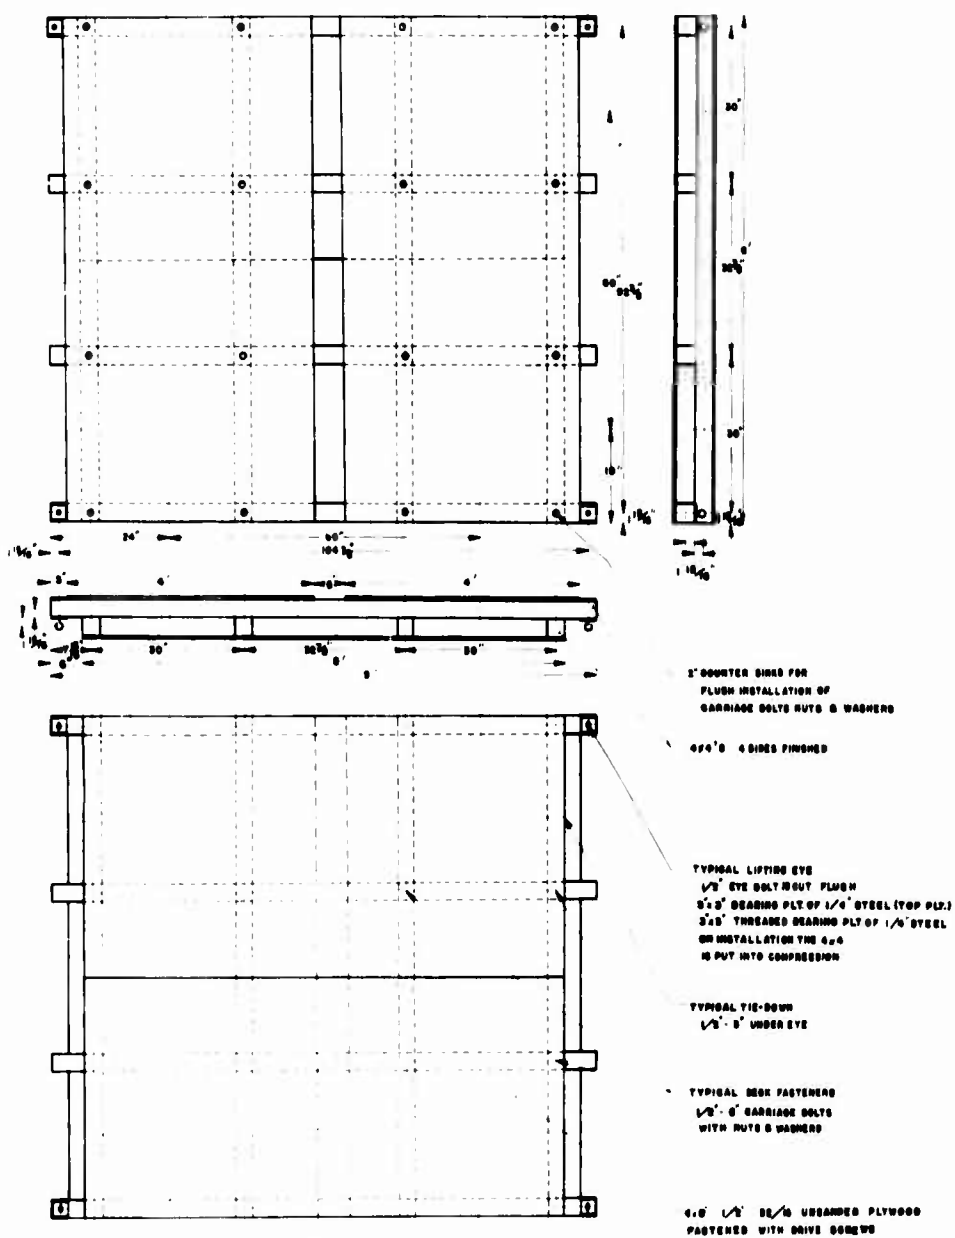
Figure A-1. Wooden large pallet.

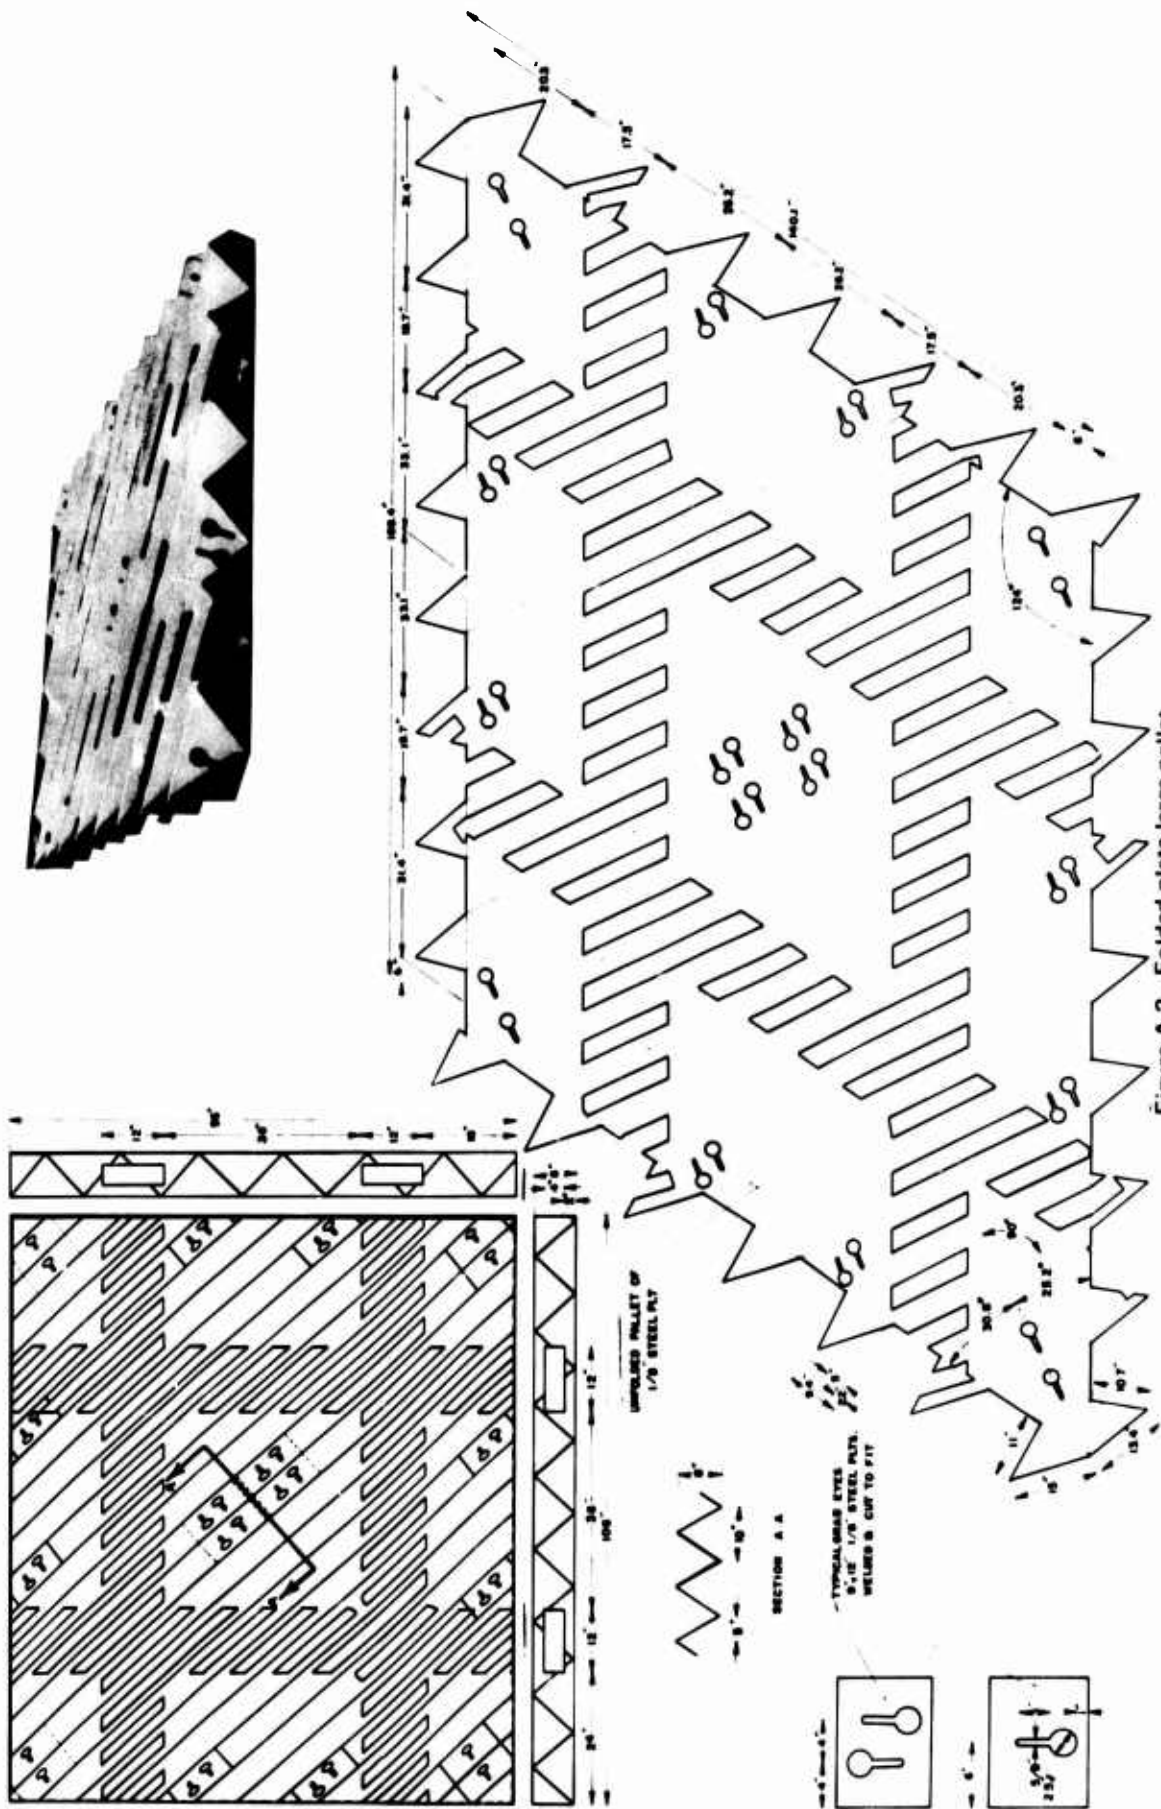
Figure A-2. Folded-plate large pallet.
